**DEPARTMENT OF TRANSPORTATION**

Contract #: 04-0120F4Cty: SF/ALA Rte: 80 PM: 13.2/13.9File #: 99.28**WELDING INSPECTION REPORT****Resident Engineer:** Siegenthaler, Peter**Address:** 333 Burma Road**City:** Oakland, CA 94607**Report No:** WIR-018868**Date Inspected:** 29-Dec-2010**Project Name:** SAS Superstructure**OSM Arrival Time:** 700**Prime Contractor:** American Bridge/Fluor Enterprises, a JV**OSM Departure Time:** 1900**Contractor:** Zhenhua Port Machinery Company, Ltd (ZPMC)**Location:** Shanghai, China**CWI Name:** Li Yang and Zhu Zhong Hai**CWI Present:** Yes No**Inspected CWI report:** Yes No N/A**Rod Oven in Use:** Yes No N/A**Electrode to specification:** Yes No N/A**Weld Procedures Followed:** Yes No N/A**Qualified Welders:** Yes No N/A**Verified Joint Fit-up:** Yes No N/A**Approved Drawings:** Yes No N/A**Approved WPS:** Yes No N/A**Delayed / Cancelled:** Yes No N/A**Bridge No:** 34-0006**Component:** OBG Trial Assembly**Summary of Items Observed:**

Orthotropic Box Girder (OBG) at Trial Assembly Areas

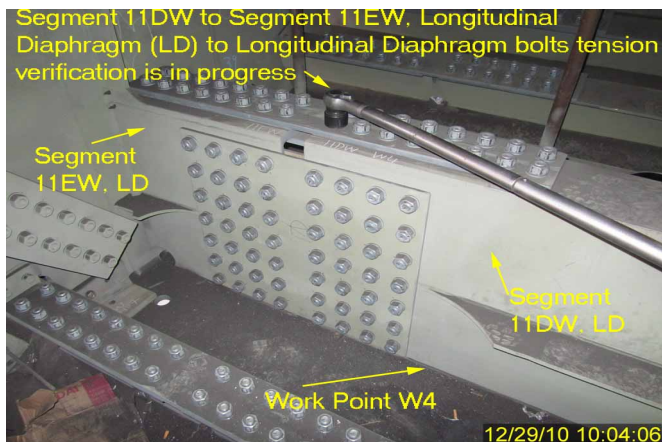
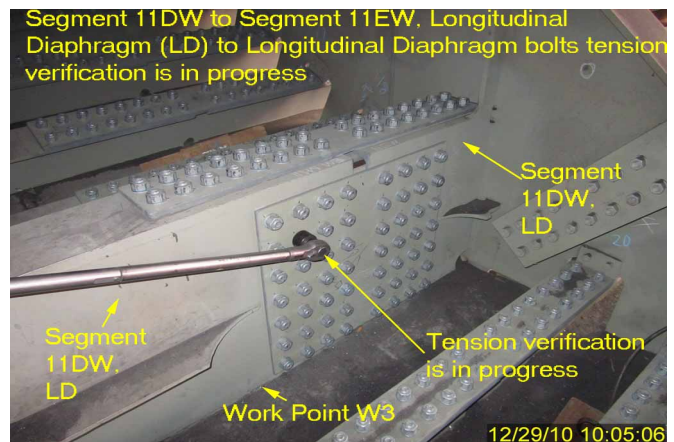
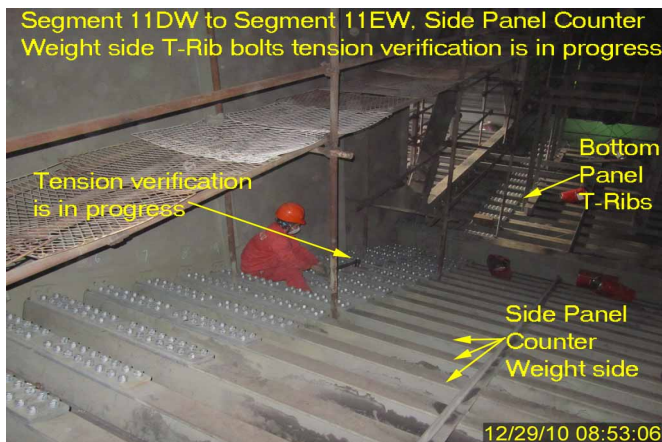
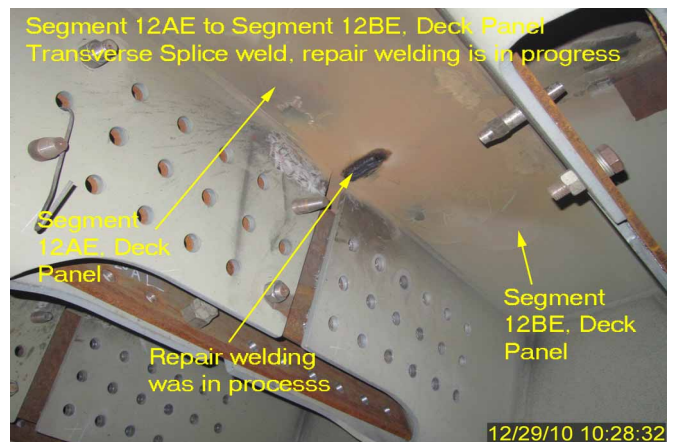
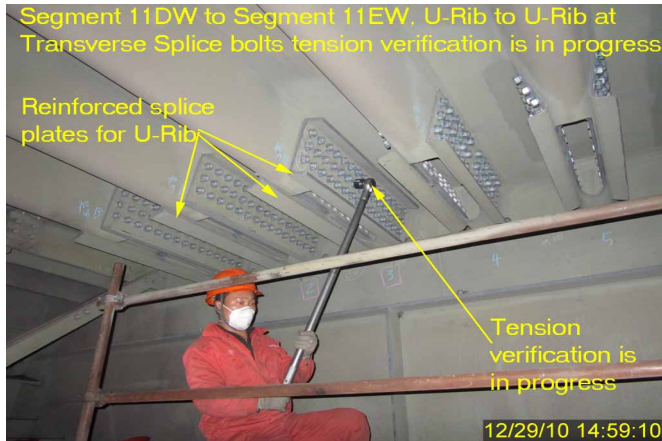
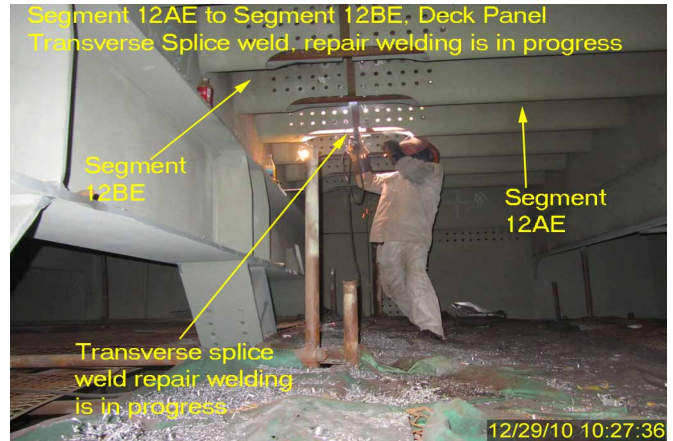
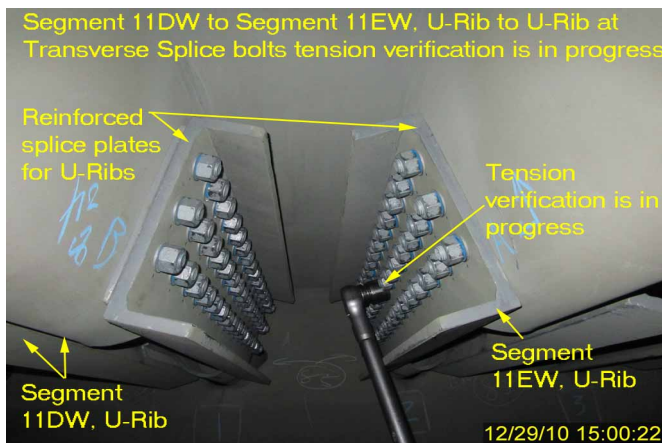
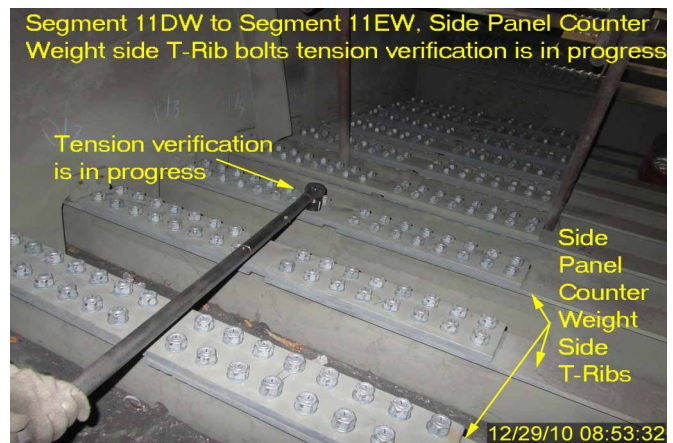
This QA Inspector witnessed the final bolt tension verification on bolts connecting the U-Rib to U-Rib at the transverse splice between Panel Points (PP) 106 and PP 107 for Segment 11DW to Segment 11EW. The QA Inspector verified the bolt tension on a random basis and the results appeared to be in general compliance. The Inspection was performed against Notification No. 00584 dated December 29, 2010.

This QA Inspector witnessed the final bolt tension verification on bolts connecting the Longitudinal Diaphragm to Longitudinal Diaphragm between Panel Points (PP) 106 and PP 107 for Segment 11DW to Segment 11EW at work point W4, Cross Beam side and work point W3 Counter Weight side. The QA Inspector verified the bolt tension on a random basis and the results appeared to be in general compliance. The Inspection was performed against Notification No. 00584 dated December 29, 2010.

This QA Inspector witnessed final bolt tension verification on bolts connecting T-Rib to T-Rib for Transverse Splice at Side Panel Counter Weight Side (from work point W3 towards W1), Bottom Panel (from work point W4 towards W3) and Cross Beam side (from work point W6 to W4) between Panel Point (PP) 106 to PP 107 for Segment 11DW to 11EW. Inspected the bolt tensioning on a random basis and found the tension to be in general compliance. Inspection was performed against the Notification No. 00584 Dated December 29, 2010.

This QA Inspector performed Dimension Control Inspection on the Transverse Splice T-Ribs to T-Ribs after bolting for the Segment 11DW to Segment 11EW between Panel Point (PP) 106 to PP 107 at the following locations:

This QA Inspector performed Dimension Control Inspection for the Segment 11AW, Segment 11BW, Segment 11CW, Segment 11DW and Segment 11EW and measured the distance between Road Barrier bolt holes drilled at X37B from deck panel to the cope hole at X37B bracket installed at Corner Assembly Cross Beam and Counter Weight side at east and west side of the X37B brackets at following locations.

Note: After performing the Dimensional Inspection, 9(Nine) locations was identified for installing the Retro-fit plates at Cross Beam side and at 10 (Ten) locations was identified for installing the Retro-fit plates at Counter Weight side for X37B brackets.

This QA Inspector observed the repair welding by Shielded Metal Arc Welding (SMAW) process on a Complete Joint Penetration (CJP) groove weld. The Weld joint was designated as OBW12-003. The welder identification was 044515 and 050289 and was observed welding in the 4G (Flat) position using approved Welding Procedure Specification WPS-345-SMAW-4G(4F)-FCM-1. The piece mark was identified as the Deck Panel, transverse splice weld.
